Manhole Inspection Summary

Manhole # S17AA1027MH

Insp Date: **3/20/07 8:35 AM**

Location Address: **2334 DRUID PARK DR**

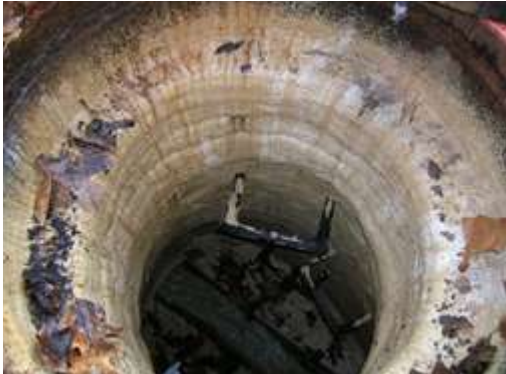
Defect

Frame leaks. Adjustment and Barrel infiltration.

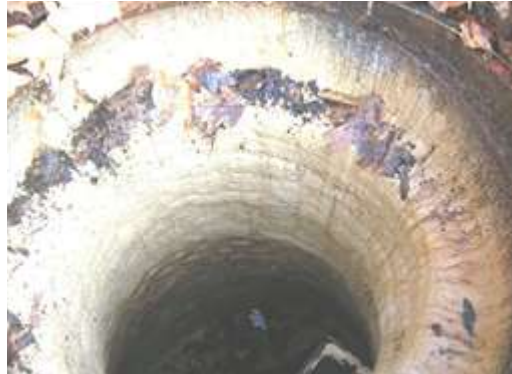
Defect

Frame leaks. Barrel infiltration.

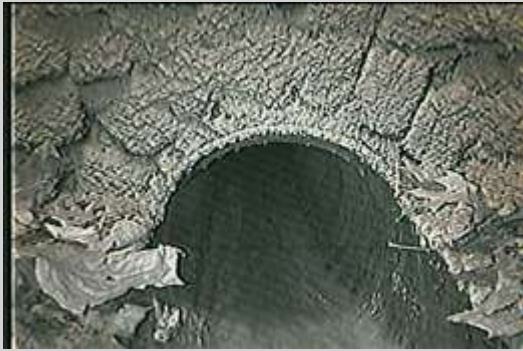
12 in. Circular Gravity Sewer Pipe Out @ 12 O'Clock

Comments **The O12 pipe picture shows Barrel deterioration.**
